- ~27 m3 of settled sludge transferred successfully from the fuel storage basin at the KE Reactor in preparation for D&D
- System/Equipment Problems caused delays in project execution
- Project Lessons Learned were compiled to relate the nature of the problems and how the problems were overcome

KBC-34834  
Revision 0  
EDC #: HNF-EDC-07-35133

## KBC Project Hose-In-Hose Transfer Project Lessons Learned

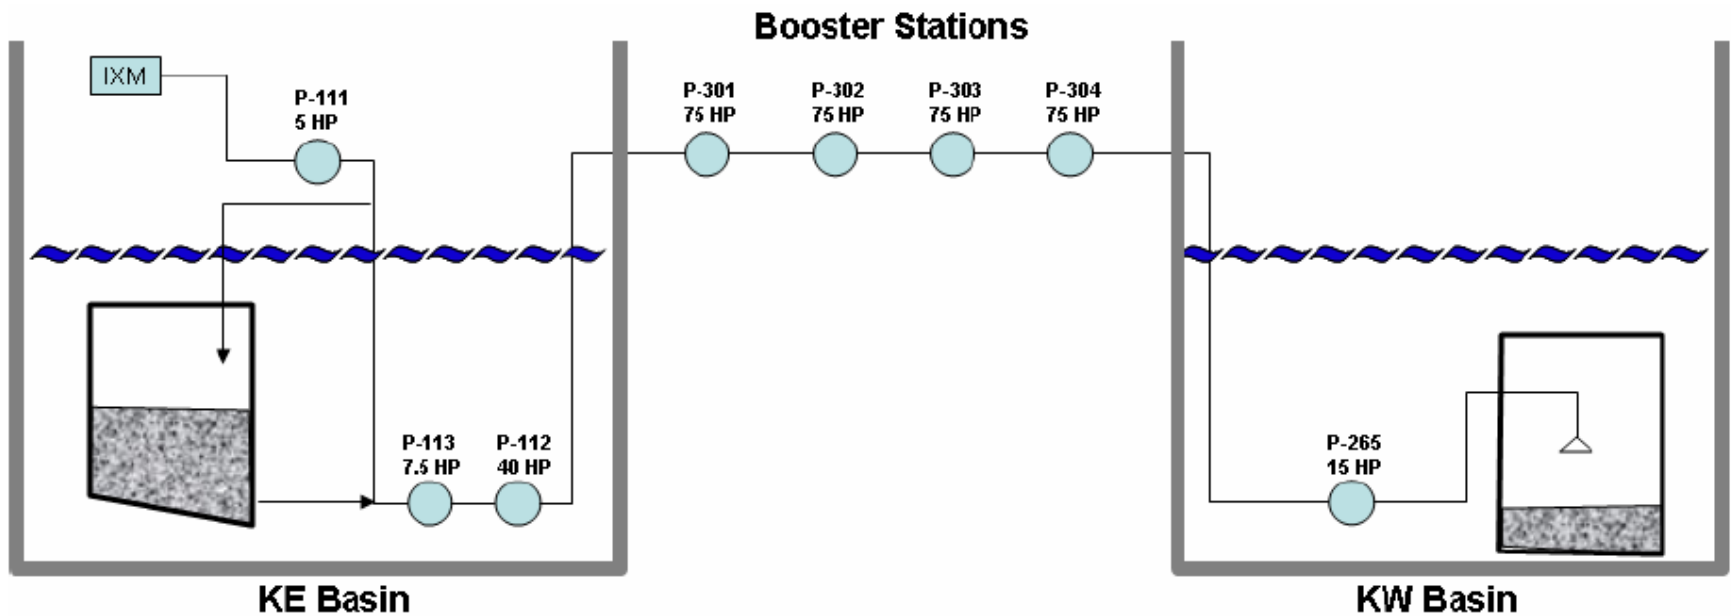
Figure 2-1 Simplified diagram of the HIH system

- Target slurry concentration ~2%weight
- Target system flow rate 64 gpm / 15 ft/sec
  - Driven by 1/4" diameter sG 19 particle
- Nominal Transfer hose ID = 1.25"
- Bottom Suction from KE container
- Dilution Control Automatic based upon solids % metering
- 7 centrifugal pumps in series – VFD Controlled (independently)
  - Suction Pump – Underwater in KE Basin
  - First Booster – Underwater in KE Basin
  - Four Above Ground Booster Pumps in Containment
  - Small Booster – Underwater in KW Basin
- Double Mechanical Seal w/ pressurized barrier fluid
- Installed Spare Pump in each station

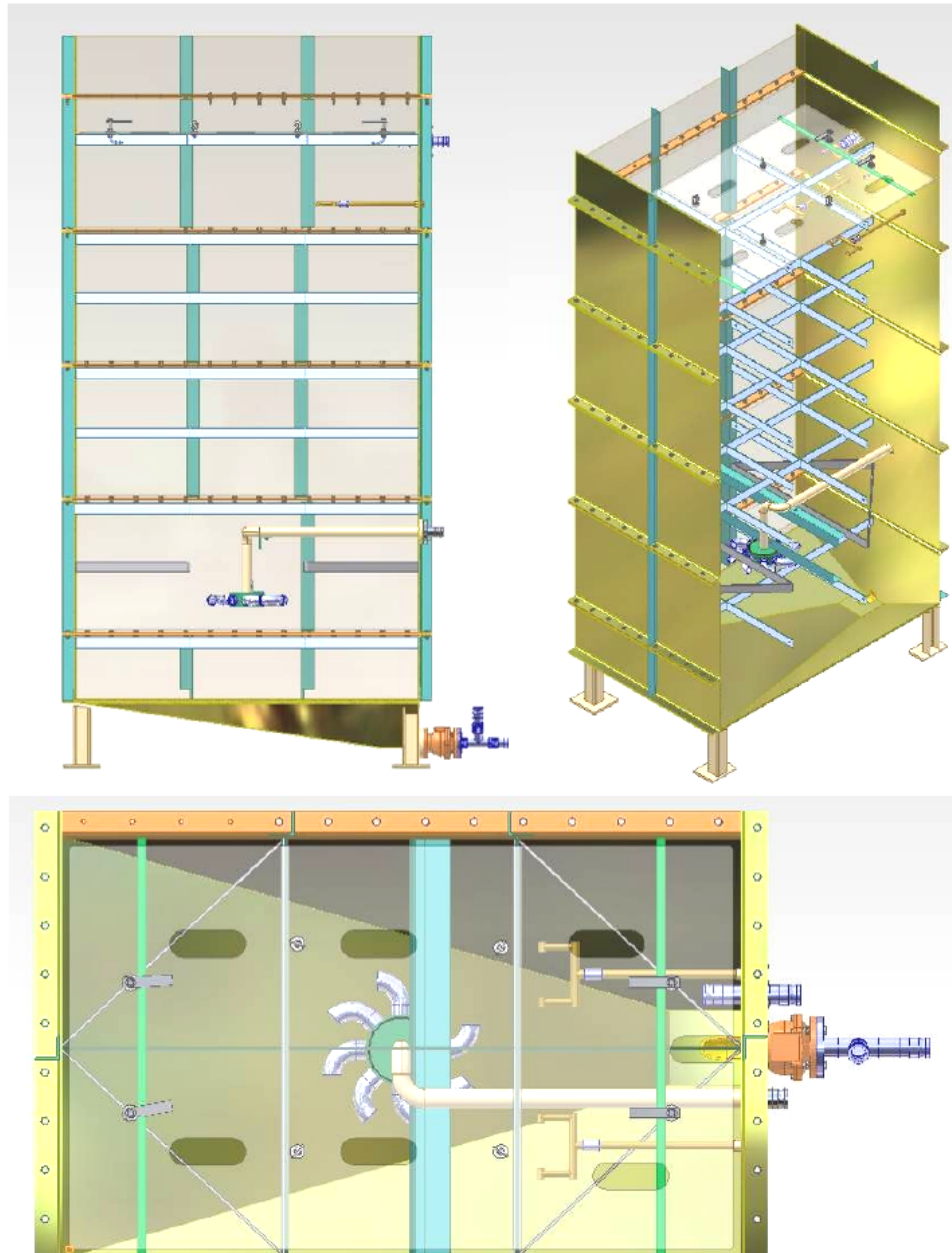
Figure 3-25 Side, Top, and Isometric Views of a Typical KE Container

- Construction Changes approved that moves dilution point further away from container (ease of operations issue)
- Foreign Material Inhibits suction line and fouls suction pump
- System trips due to insufficient suction pressure

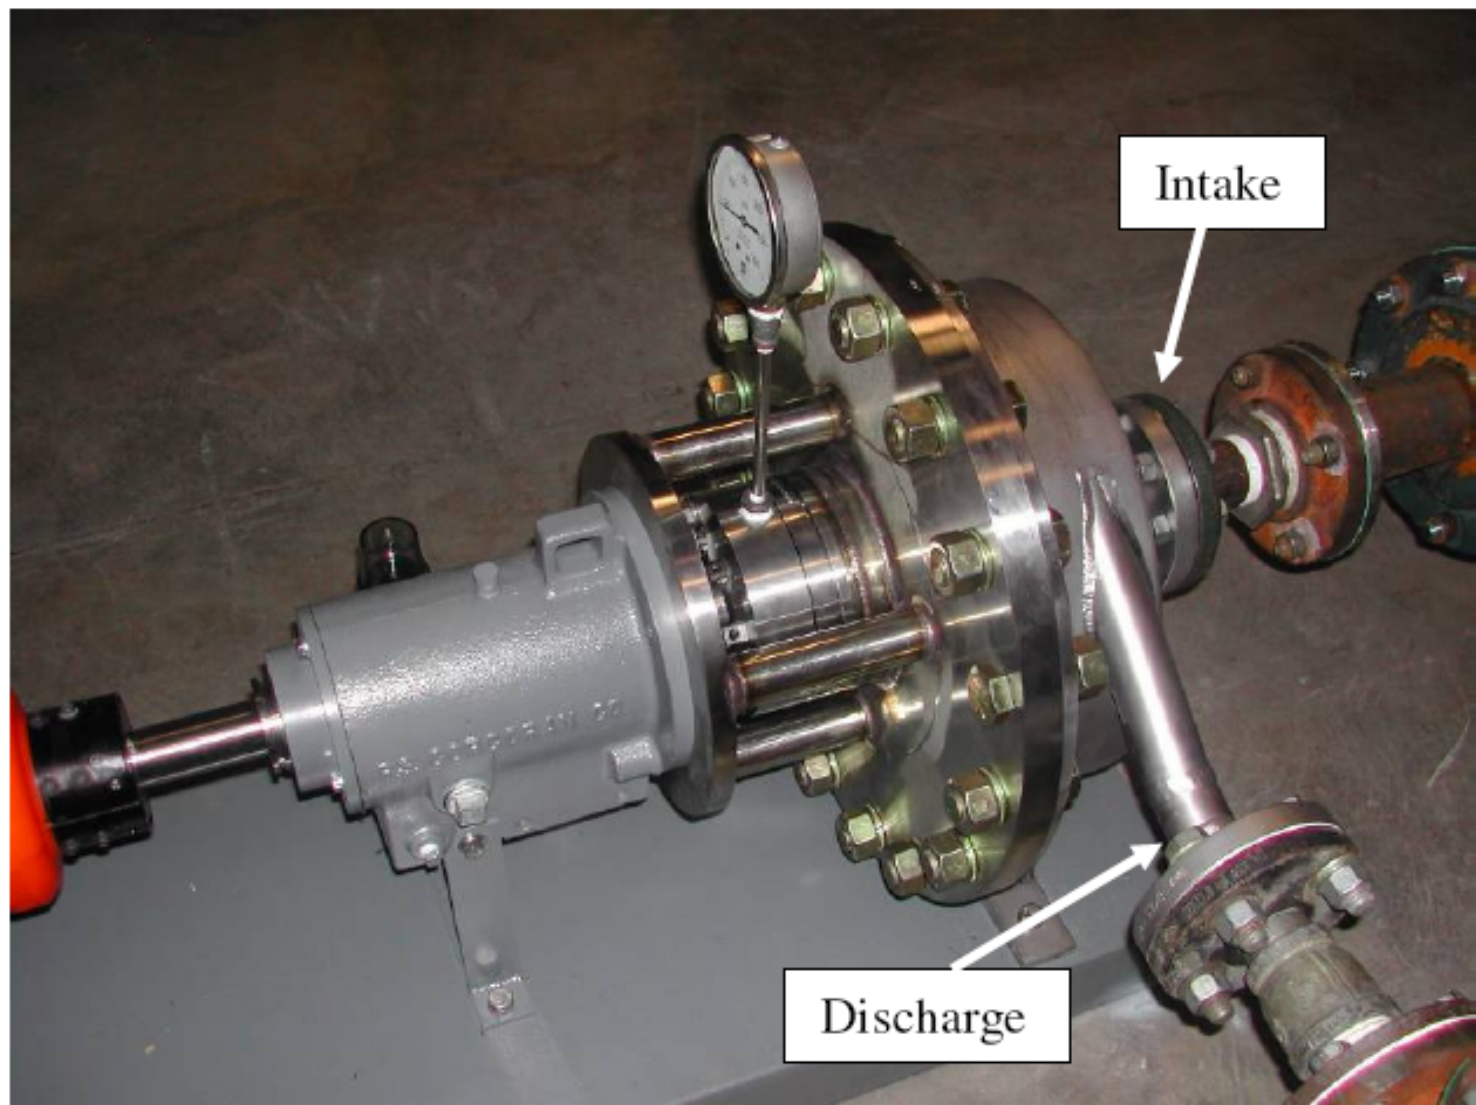
**Figure 3-14 HIH Booster Pump**

## Underwater Booster Pump experienced multiple wear failures

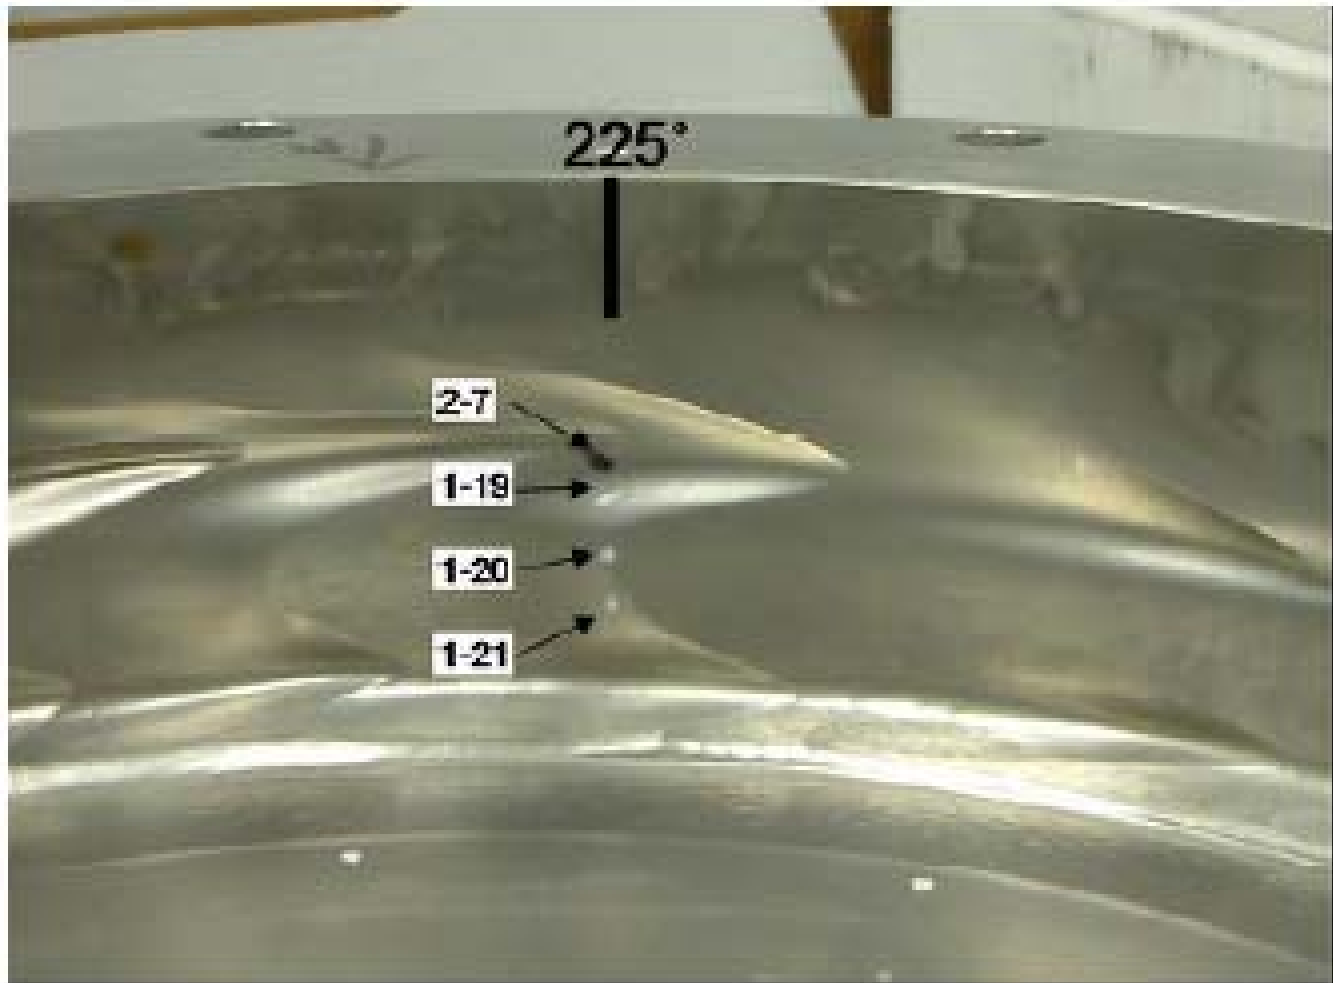
Test Results Drove Requirement for Monitoring of wear using UT thickness sensors fixed to pump and read remotely
